# Re-Inventing the Nation's Urban Water Infrastructure (ReNUWIt)

## Research conducted through the ReNUWIt Research Scholars (RRS) Program.

# Evaluation of giant sacaton grasses for riparian rehabilitation (RRS4)

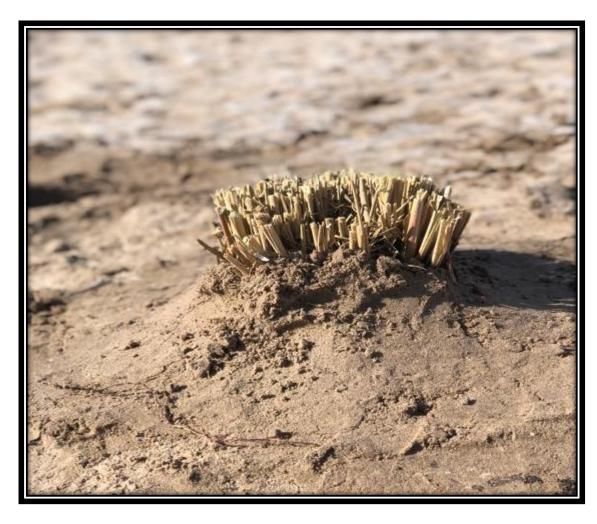
Giant Sacaton planted on 2/8/2019. Figure

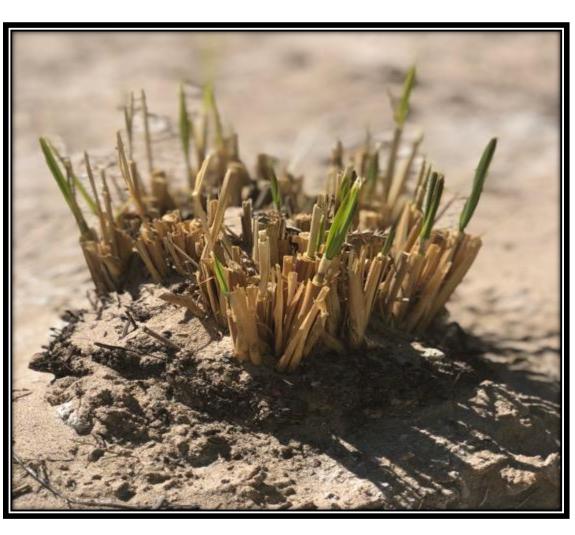
Figure 3. Giant Sacaton progress two weeks after planting and irrigation.

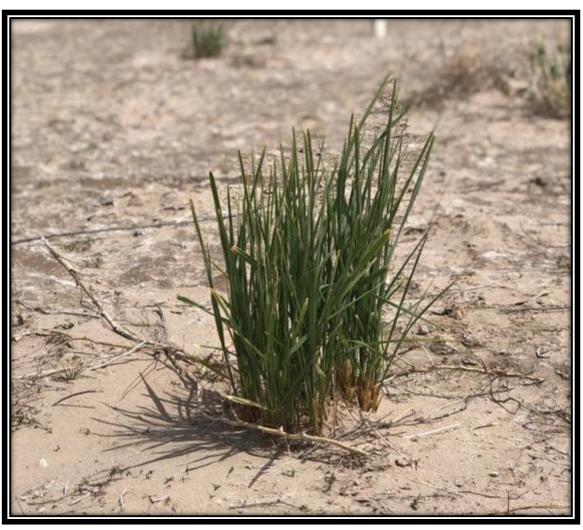
**Figure 5.** Giant sacaton grasses are looking healthy

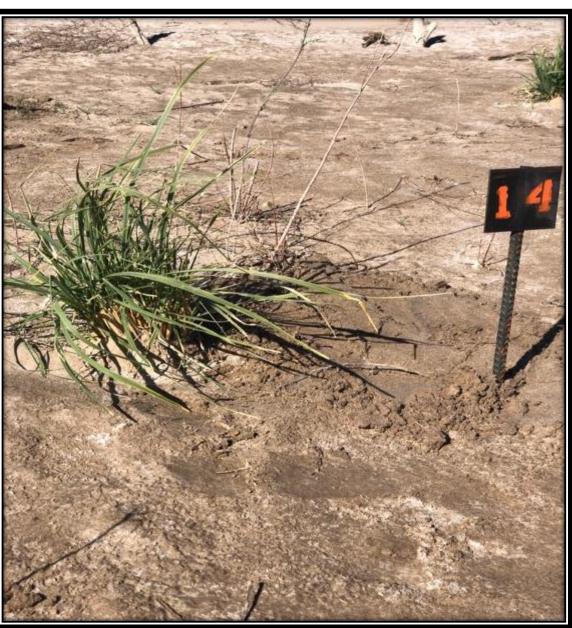
Figure 7. All plants are growing well (April 19, 2019)

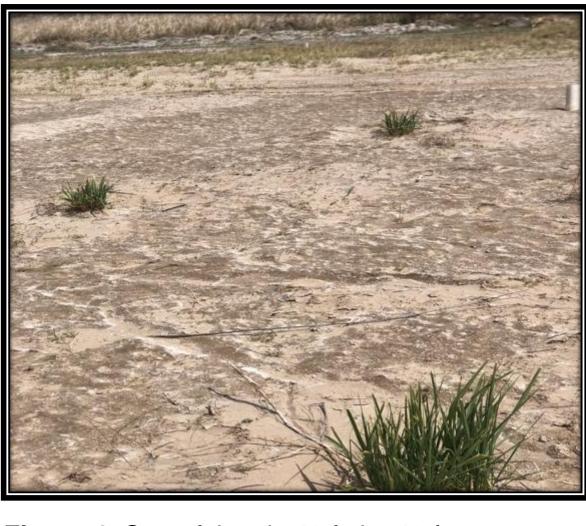
Figure 6. Giant Sacatons one month after planting

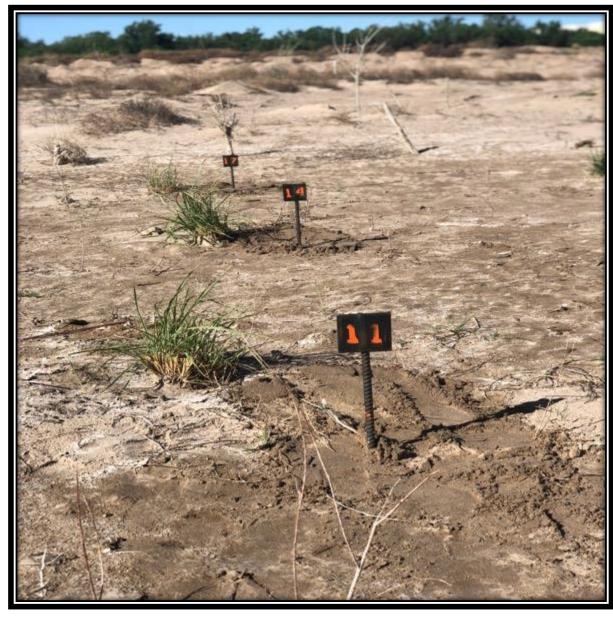
Figure 8. Soil is still moist after two months of planting
